## **Parking Capital Improvement Program Plan (CIPP) Summary**

**University of Hawai'i at Mānoa**  
Honolulu, HI

June 22, 2018

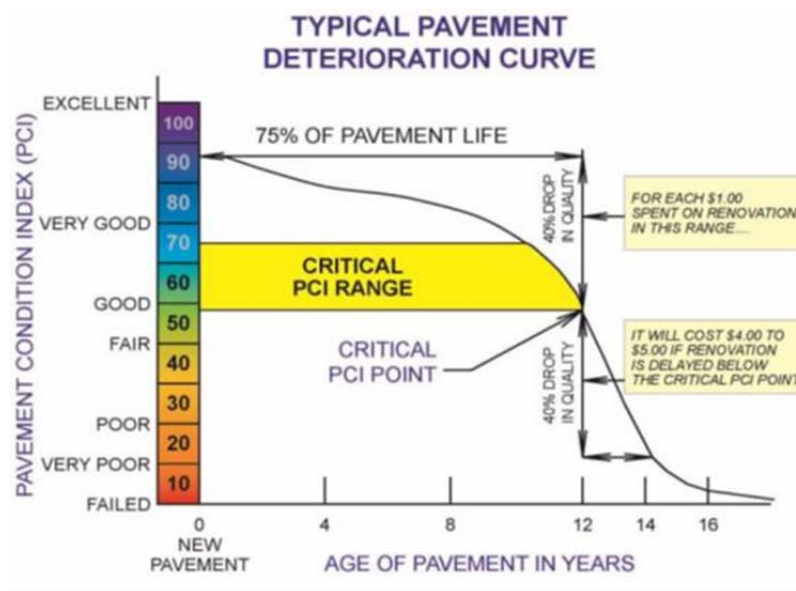
Figure E-1

The parking area pavement is at the critical point, such that delaying repairs beyond this critical point will begin to see a sharp increase in repair costs as pavements below the critical point will require more substantial and expensive repairs. This typical pavement deterioration curve is shown below and is a visual representation of what the critical point means. Factors including but not limited to original section design, quality of original construction, subgrade condition, traffic loadings, climate, and the quality and extent of the maintenance program in place all help to shape a pavement deterioration curve.

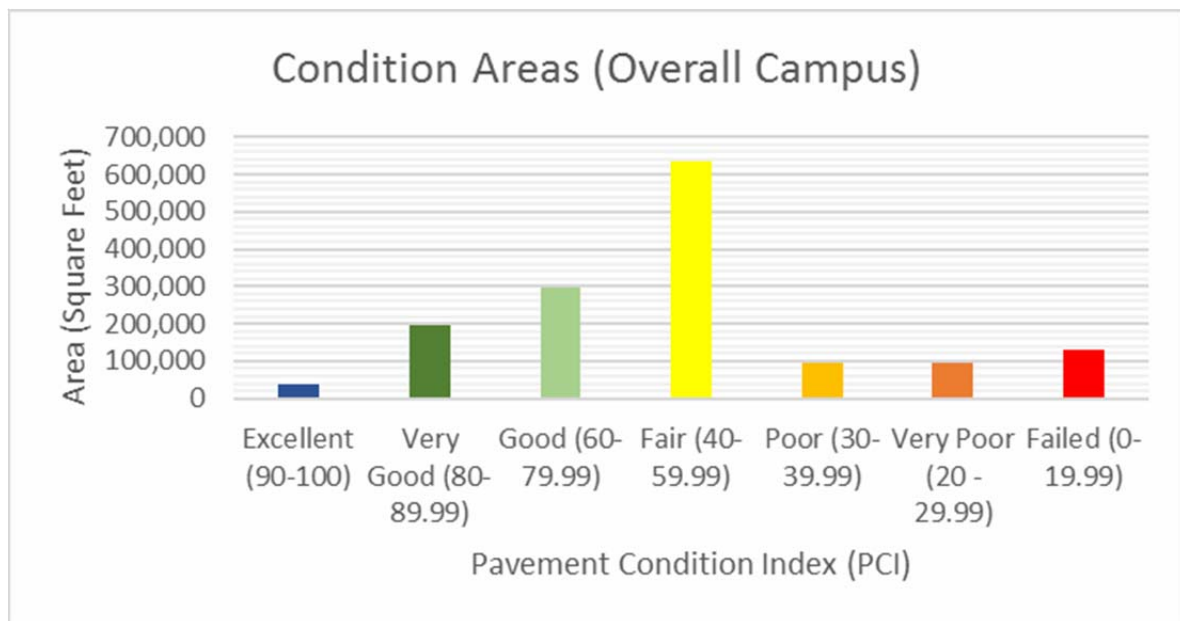
Figure E-2

The overall condition of pavements on campus lots is shown visually in the graph in Figure E-2, which divides the pavement into condition ratings and shows the magnitude of pavement area rated in each condition. The bar graph depicts the condition trend observed across the campus with nearly 65% of the pavement is at or beyond the critical range and these areas require attention. Observed conditions of all parking lots is depicted in the attached aerial sheets at the end of this document.

Based on the observations made in the field, a heavy focus should be placed on preventative maintenance to extend the service life of the pavements that are in the critical range. These preventative repairs should be supplemented by a combination of rehabilitation and reconstruction to most cost effectively repair the lots.
